# Clarification Regarding Road Surface Cave-in on Delhi–Dehradun Economic Corridor Following Heavy Rainfall

प्रविष्टि तिथि: 02 JUL 2026 4:43PM by PIB Delhi

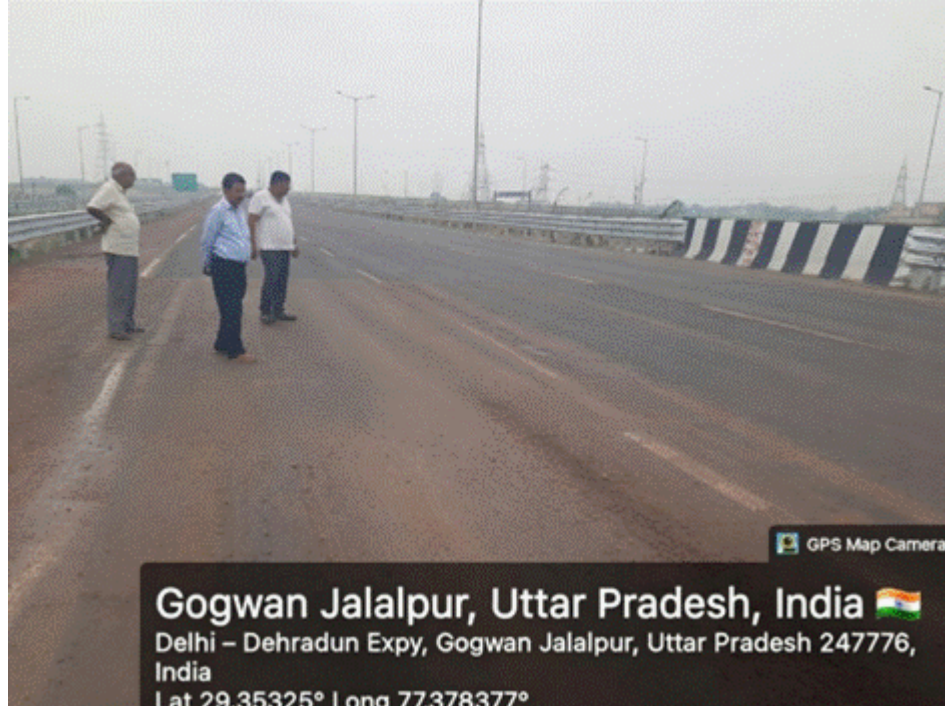
Km 55 after restoration — Gogwan Jalalpur, Delhi–Dehradun Expressway

During routine route patrolling in the early hours of 1 July 2026, the project team detected the affected stretch and immediately initiated restoration works. The damaged portion was repaired on priority, ensuring safe and uninterrupted movement of traffic.

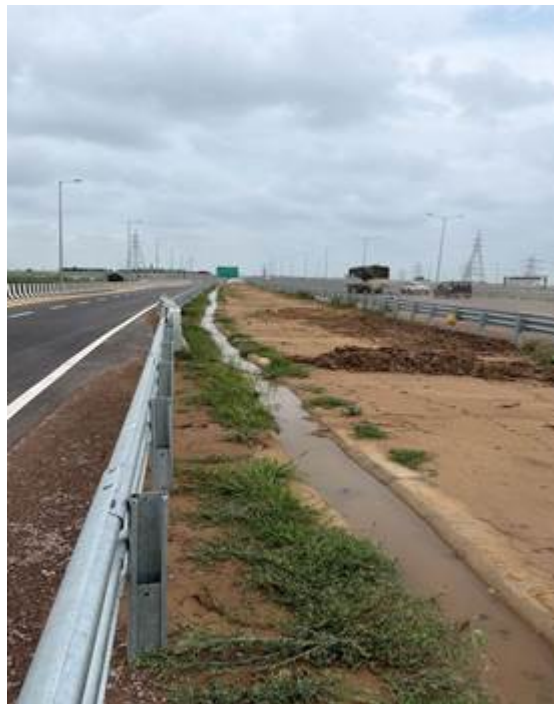
Parallel drain between main carriageway and loop (~1.5 km)

To address the situation, NHAI has initiated construction of an interim parallel drain of a length of approximately 1.5 kilometres. The drainage gradient is being redesigned to safely convey rainwater up to the entry/exit location at Km 56+500, pending commissioning of the balancing culvert.

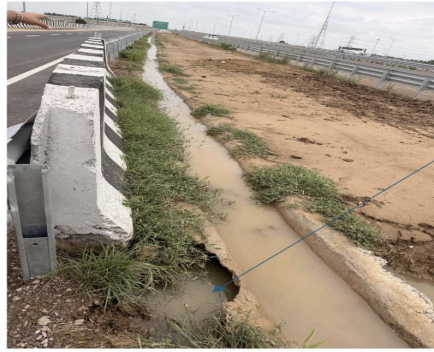
Balancing  
Culvert  
location  
ponding

The balancing culvert constructed at Km 55+480 was designed to facilitate cross-drainage by conveying rainwater across the median and safely away from the carriageway. However, the culvert could not be connected and commissioned because of sustained resistance from local residents, who have not permitted integration of the drainage system and have instead been using the culvert opening as a vehicular crossing. Consequently, the intended cross-drainage arrangement has remained non-operational, leading to accumulation of rainwater along the carriageway during the heavy rainfall and the subsequent road surface cave-in.
